# **ACTON CONSERVATION AREA**

**Australian Capital Territory**

# Heritage Management Plan

March 2011

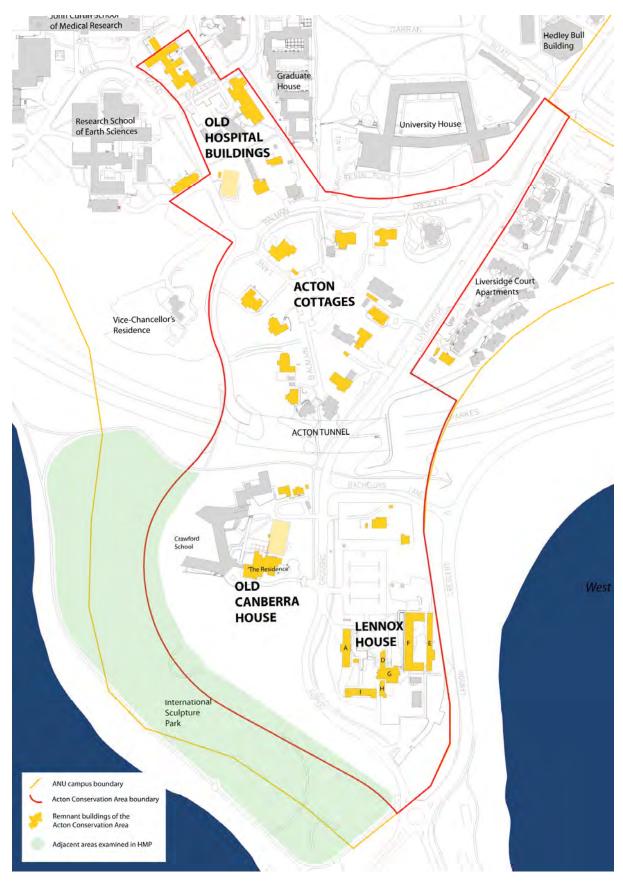
Figure 2.2: Site features of the Acton Conservation Area (ANU Heritage Office).

Note: Numbers 8 Liversidge Street and A Block of the Old Hospital Buildings are included as elements of the site, though are not included in the official Acton Conservation Area boundary on the Commonwealth Heritage List.

The study area for this assessment has been defined by DSEWPC, as based on the boundaries described by the Commonwealth Heritage List entry for the Acton Conservation Area (Appendix 2). Adjacent sites that are also examined include the cottage at No. 8 Liversidge Street, the old Women's Ward (B Block) of the Canberra Community Hospital and the landscape to the southwest of the Old Canberra House zone (Figures 2.2-2.3).

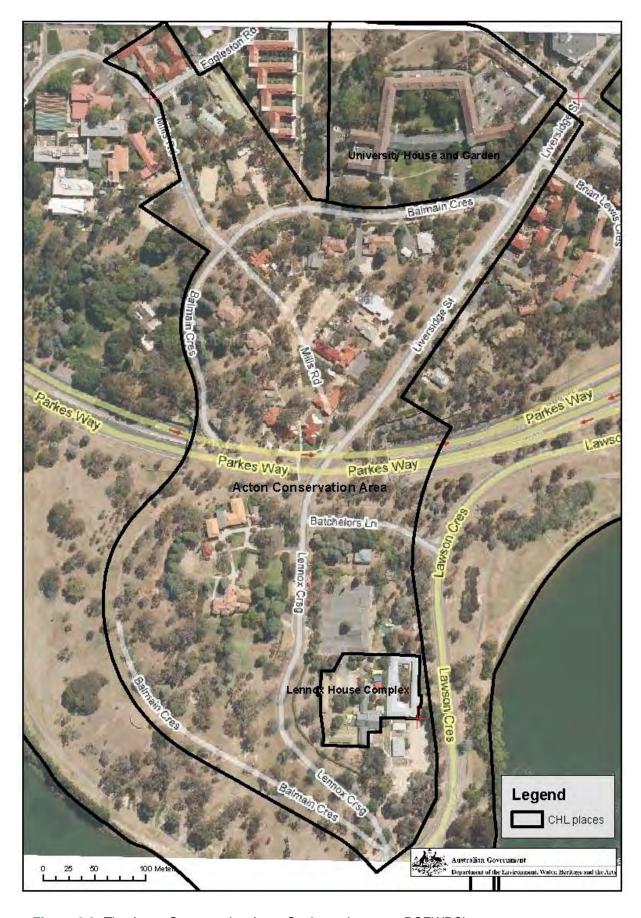
Figure 2.3: The Acton Conservation Area, Canberra (courtesy DSEWPC).

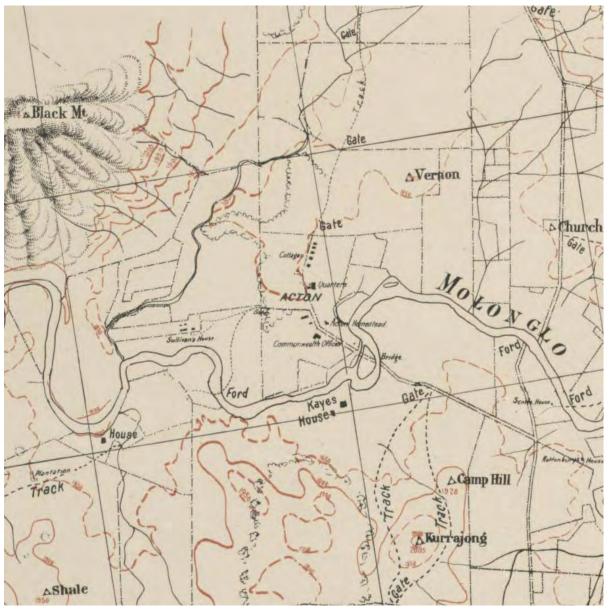
Figure 3.2: Acton area, 1912. Acton Homestead and the Springbank complex are illustrated, along with the Commonwealth Offices, Bachelors Quarters and the first five cottages for married administrative staff (Lands & Surveys Branch, Dept. of Home Affairs) (NLA 117433).

The first building of the Commonwealth Office complex was completed on 22 August 1912 to the south of the Ridge. The Offices were shortly followed by the construction of five weatherboard cottages for married staff, situated above the Bachelor's Quarters to the north (today part of the Acton Cottages zone). Administrative staff soon arrived, including the Administrator of the Federal Territory, who was to oversee the early development of the city. His Residence (today Old Canberra House), the first double storey brick house built in the new Territory, was constructed

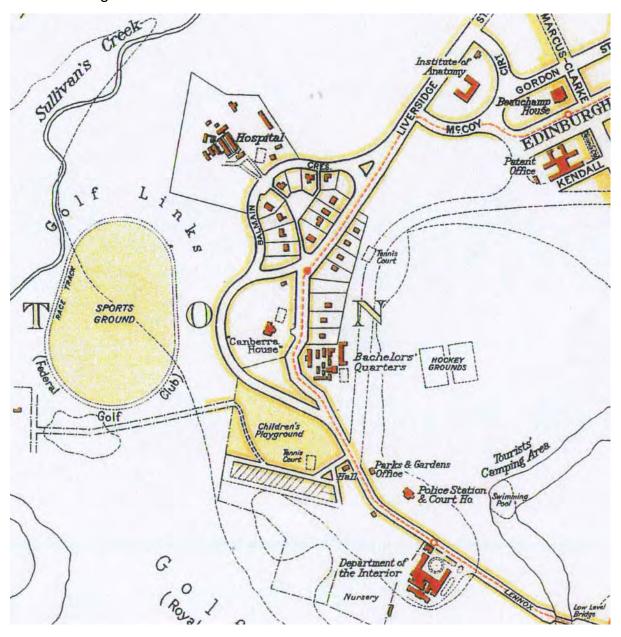
**Figure 3.6:** Acton, 1933. By the early 1930s the Acton 'village' had been formed, with workers' cottages kept separate from lower level accommodation (Bachelors Quarters) and upper level accommodation (Canberra House). The Hospital was extended in 1928 to the north of the residential area (NLA 2931052).

Recreation facilities were an important part of life in the Territory. By the early 1930s five tennis courts had been formed in the Acton area, as well as hockey grounds to the east of the Bachelors Quarters. The Acton racecourse was established on the floodplains to the west and included a cricket pitch and sporting grounds. The racecourse was skirted by the Royal Canberra Golf Club (actually the second course in Canberra). A large children's playground was constructed to the south of the site in the 1920s and smaller playground facilities were located around the residences (refer Figure 3.6).

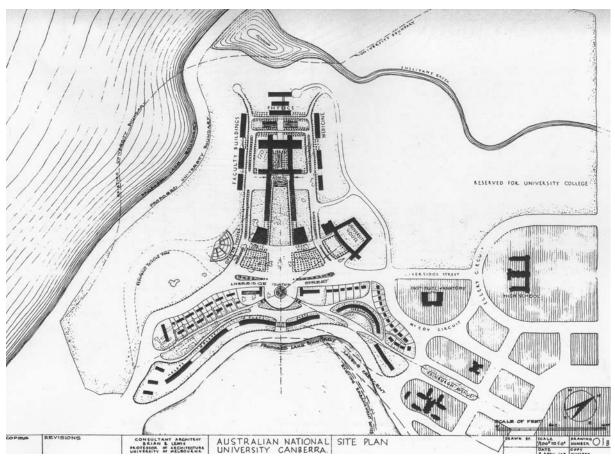
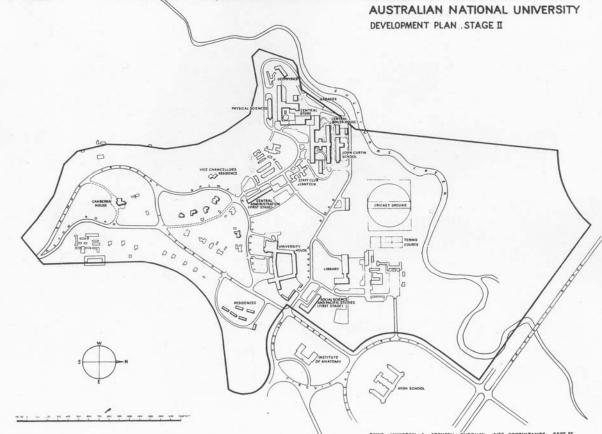
**Figure 3.7:** Professor Brian Lewis' first site plan (top) illustrated extensive developments in the Acton area, with only Old Canberra House remaining. The 2nd 1955 site plan detailed much less invasive works, with the retention of the early buildings (Dexter 1971: plates 8 & 15).

In 1955 a number of site development plans were prepared by Professor Denis Winston and Grenfell Ruddock. The first detailed extensive alterations to the Acton buildings; the Balmain Crescent cottages largely replaced by a University Tower/Theatre complex and the married mens' cottages and Bachelor's Quarters replaced by a new Residential College. The second plan, submitted in September 1955, detailed much less invasive developments; the early Acton cottages and the Old Canberra House complex were retained (Figure 3.7).

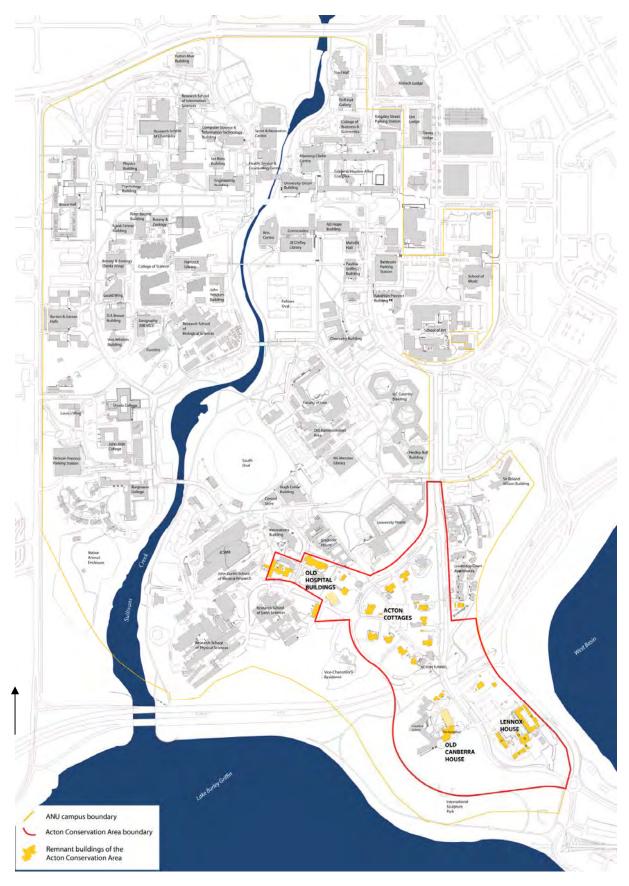
**Figure 3.8:** The remnant Acton buildings and the Acton Conservation Area as part of the modern ANU campus (ANU Heritage Office).

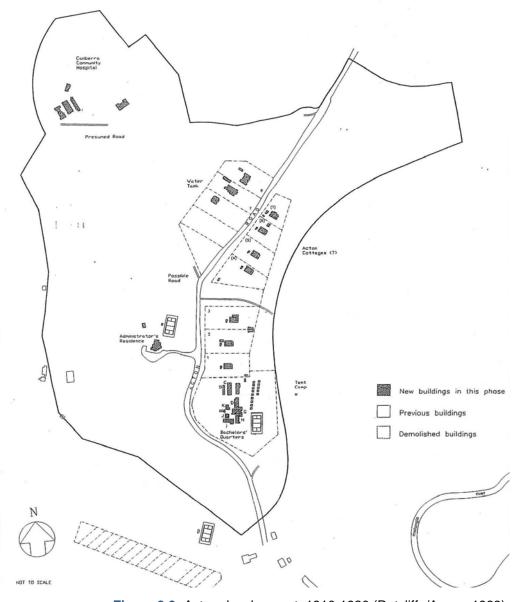
Figure 3.9: Acton development: 1910-1920 (Ratcliffe/Armes 1993)

A number of tent camps were established in the Capital in the early twentieth century to house the surveyors and draftsmen; the Acton Camp was established in 1911, shortly followed by the construction of a mess hall (G Block) and other semi-permanent buildings to serve as sleeping quarters for single men (D, H and part of I Blocks of the Bachelors Quarters). The Administrator's Residence was constructed uphill to the west, with a garage, small gas plant and tennis court and shed. Cottage Numbers 1-7 were constructed to the east of Acton Road, shortly followed by Numbers 6 and 7 Liversidge Street across the road north of a large water tank. The first five buildings of the hospital complex were constructed to the north-west of the residential precinct.

Much of the planning layout was established in this phase, principally the class segregation dictated by the contours of the land and a separate hospital area. The gardens and landscapes of the early houses were formally planned by Weston's Afforestation Department.

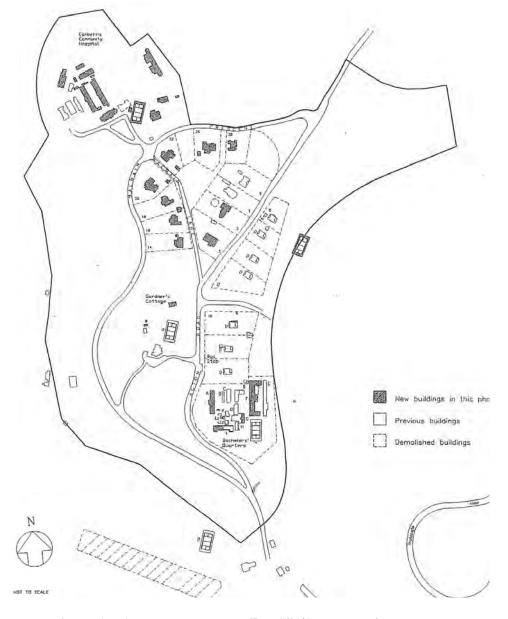
Figure 3.10: Acton development: 1920-1930 (Ratcliffe/Armes 1993)

Blocks B, C, F, J, K, L and M were added to the Bachelors Quarters and the Wardsman's Flat was extended to become I Block. The gardener's cottage and shed were likely constructed at the Residence (to become Canberra House in 1925) and to the north nine weatherboard and brick houses were constructed for middle and upper-income public servants (to become the Balmain Crescent residences). The original hospital complex was heavily extended to become the Canberra Community Hospital, including new Administration and Kitchen Blocks, larger Male and Female Wards, Obstetrics Block, Laundry, Isolation Ward and tennis court. The Animal Laboratory and Animal House were constructed for the Department of Health to the southeast of the hospital complex.

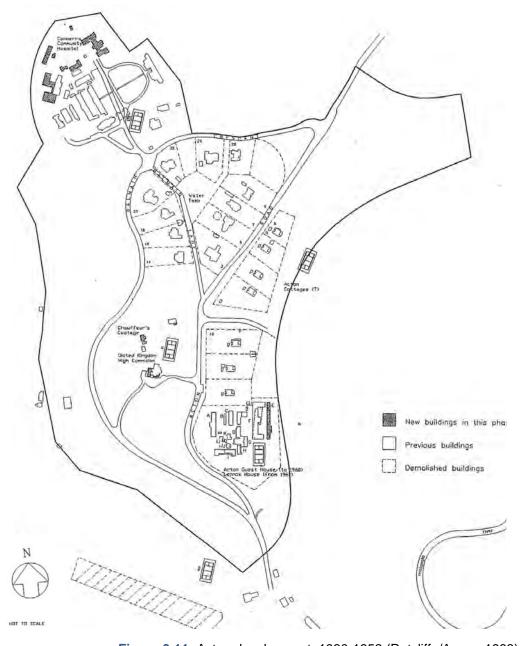
Figure 3.11: Acton development: 1930-1952 (Ratcliffe/Armes 1993)

New buildings in this phase include E Block of the Lennox House complex. Canberra House (to become 'Old Canberra House' in 1952) was extended to accommodate the British High Commission and the chauffeur's cottage was constructed. The large Nurses Quarters appears to have been built in the early 1930s, in line with other modifications to the Community Hospital complex. The construction of the new (Royal) Canberra Hospital at the end of Acton peninsula in the early 1940s saw an end to public hospital facilities in the original complex.

The Acton buildings were handed over to the Department of the Interior, who gradually converted the hospital buildings into offices and the Bachelor's Quarters into the Acton Guest House. The cottages were to remain residential premises, providing accommodation for foreign diplomats and middle to upper-level public servants. The site was vested to the ANU in the early 1950s, with most buildings falling under their direct control in 1952-53.

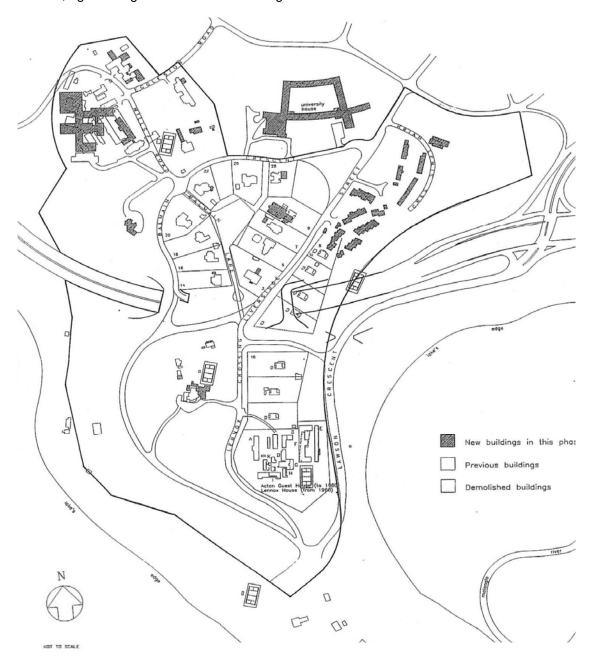
Figure 3.12: Acton development: 1952-1990 (Ratcliffe/Armes 1993)

Old Canberra House was gradually extended and heavily modified in line with its conversion to commercial premises in 1955. A number of houses were burnt down and most of the original 1913 workers' cottages were demolished to make way for the Acton 'Underhill'/Parkes Way Tunnel in the 1960s-70s. The old Department of Health Laboratories were converted into the ANU Gardener's Depot and the Hospital complex was largely demolished or heavily extended to make way for the Research School of Earth Science buildings.

The John Curtin School of Medical Research and the Research School of Physical Sciences were built to the northwest of Acton in the mid-1950s, as well as University House to the north of Balmain Crescent. The Vice-Chancellor's Residence was constructed to the west of the Acton Cottages in 1958, set amongst large open gardens with sweeping views. The Brian Lewis Crescent houses, Liversidge Court Apartments and the Judith Wright Apartments were constructed to the northeast of the site, again designed to take full advantage of the views.

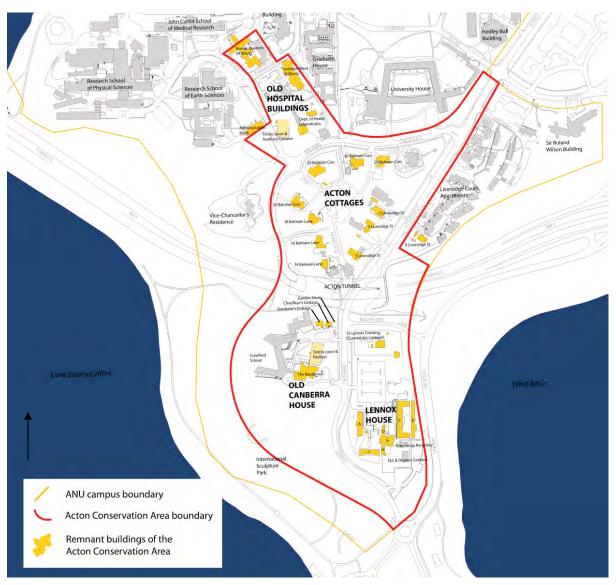
Figure 3.13: The Acton Conservation Area, 2009 (ANU Heritage office).

A large demountable was installed on the vacant block of 9 Liversidge Street and the Acton cottages altered or extended to provide additional space for University offices or child-care facilities. A compound was formed to the rear of 7 Liversidge Street for storage of field equipment and the Winston Churchill Trust cottage was constructed at the northwest tip of Balmain Crescent. Two modern 'cottages' were also constructed at the southern end of the cottages zone for the National Europe Centre.

The old Community Hospital buildings have been impacted upon by University developments, including the demolition of the old Women's Ward (B Block) in 2010. Extensions have been added to the Nurses Quarters and Isolation Ward. The layout of the Health Laboratories has been retained and is an important element of the site. It is interesting to note that these buildings suffered relatively little alterations after they were converted into the Gardener's Depot.

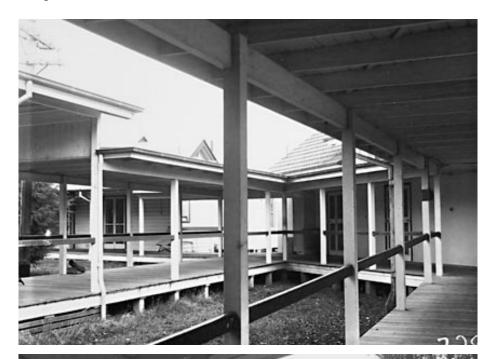
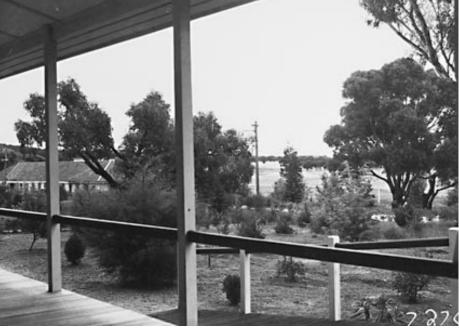
Figure 3.14: The elongated weatherboard buildings of the Lennox House and Hospital complex (seen here in 1935) were connected via a series of covered walkways, with verandahs providing sweeping views of the Molonglo River (NAA A3560, 7290; NAA A3560, 7274).

The first Administration Buildings were constructed to the south of Acton, of the ubiquitous elongated weatherboard form that was to become the standard design for many of the Acton buildings. The hospital was constructed in similar fashion in a relatively isolated location to the northwest that took advantage of the views of the Molonglo River below (Figure 3.14).

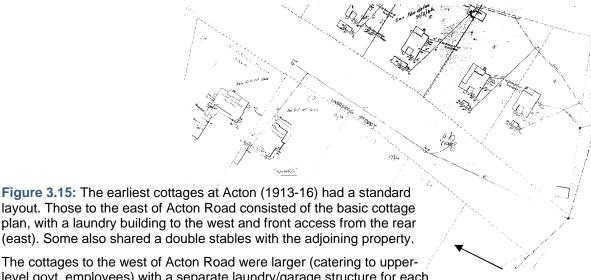
The cottages to the west of Acton Road were larger (catering to upper-level govt. employees) with a separate laundry/garage structure for each house. All had generous building setbacks, separated by hedges or wire fencing and hedges lining the road (ANU Drawing Office).

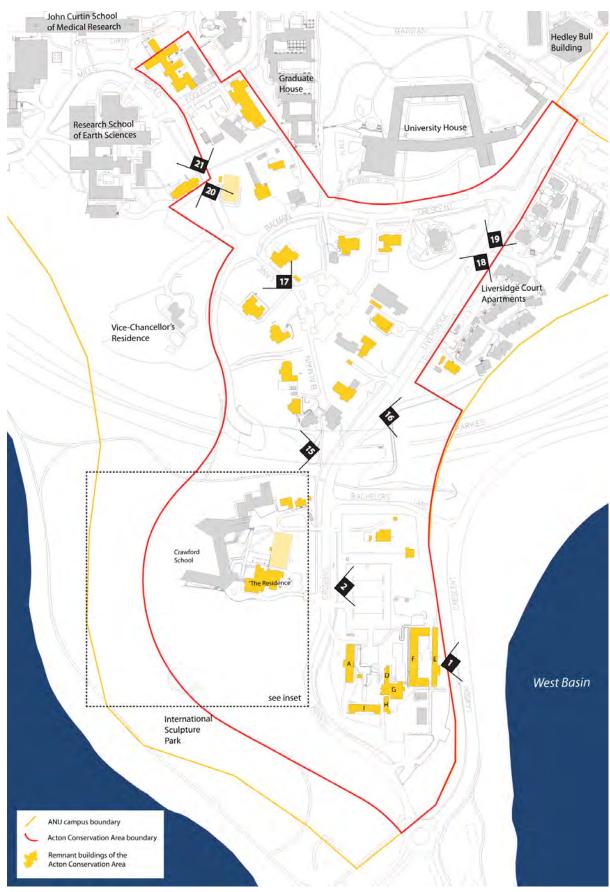
Figure 3.17: Significant views within the Conservation Area (refer to table below).

Vie	w Character	View Connection	Significance	Image
LEI	NNOX HOUSE ZONE			
1	View east of Lake Burley Griffin (West Basin) from E Block	The original views (from F Block) were of the open floodplains, with the Molonglo River arcing into the Basin. Current views connect the landscape around West Basin with the City Centre beyond and Mount Ainslie in the background.	The views provide a link between the Bachelors Quarters and the Canberra City Centre.	
2	View east from Lennox House carpark	The carpark was formed on the site of Cottage *s 1 and 2. Similar views were visible from these cottages (see also view *16).	This view is similar to View #1, though is more confined. A break in the vegetation provides a good reflection of the original views from the first workers' cottages. The Lake, Russell Offices, Aust-American War Memorial, City Centre and distant ranges can be seen.	
3	View east of Lennox House from Old Canberra House south gardens	The eastern side of Lennox Crossing (Lennox House) was originally fenced, whilst those of the west (Old Canberra House) were lightly obscured by hedges.	The hedges and fences are an important visual break, separating the lower-level Lennox House with upper-level Old Canberra House.
